# CASPIAN LAKE DAM

VT 00183

## PHASE I INSPECTION REPORT NATIONAL DAM INSPECTION PROGRAM

JANUARY 1979

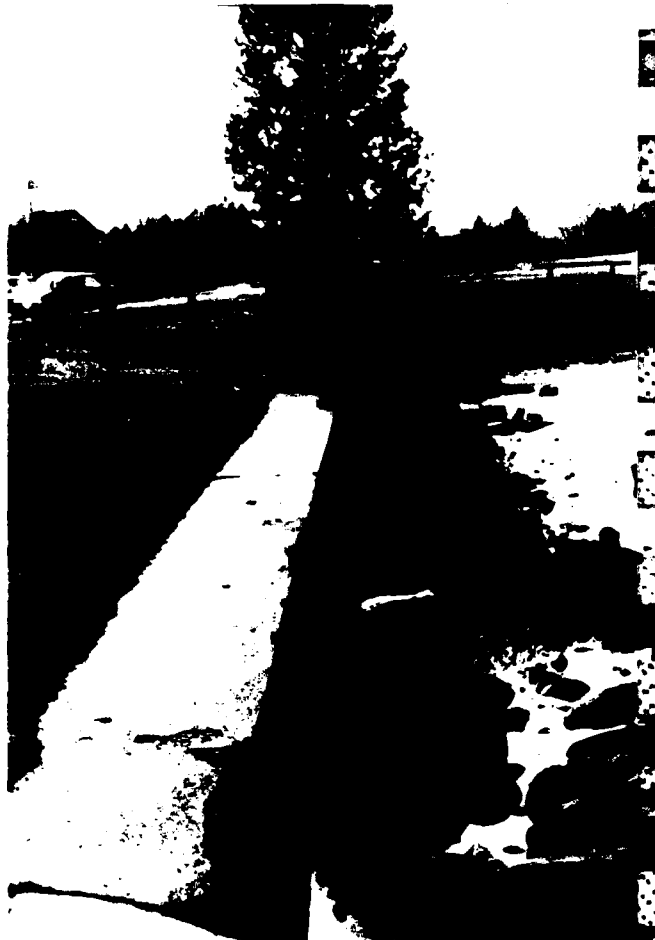
The concrete gravity retaining wall between outlet works structure and the right "abutment" of the dam appears to be in stable and good condition; some cracks and spalling, however, were noted as shown in Photo 8.

PHOTO NO. 8 - Upstream face of  
dam from spillway structure  
to right "abutment".

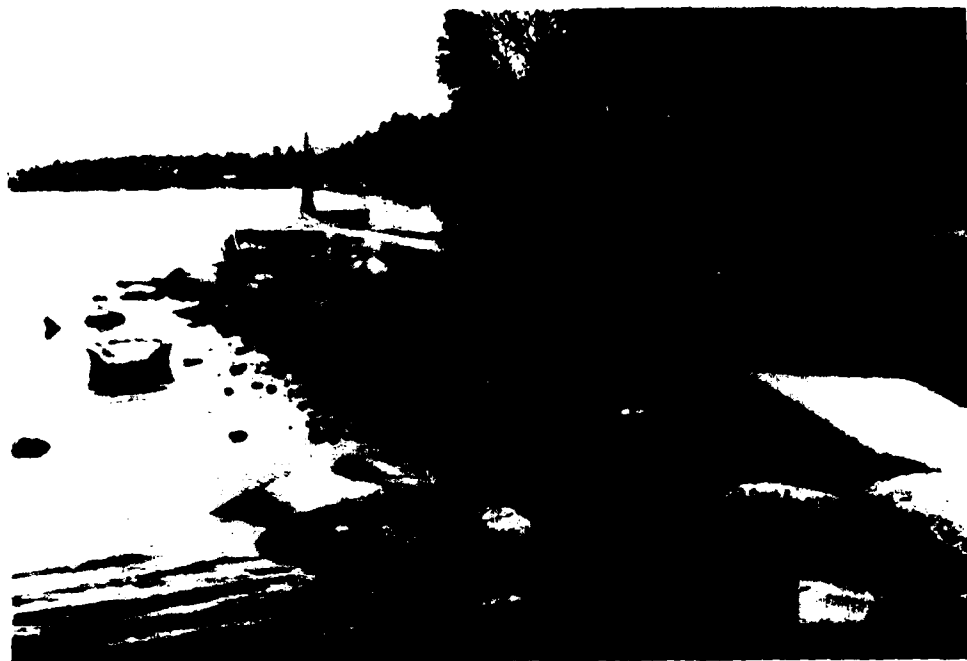
PHOTO NO. 6 - Upstream slope of the dam at right abutment.

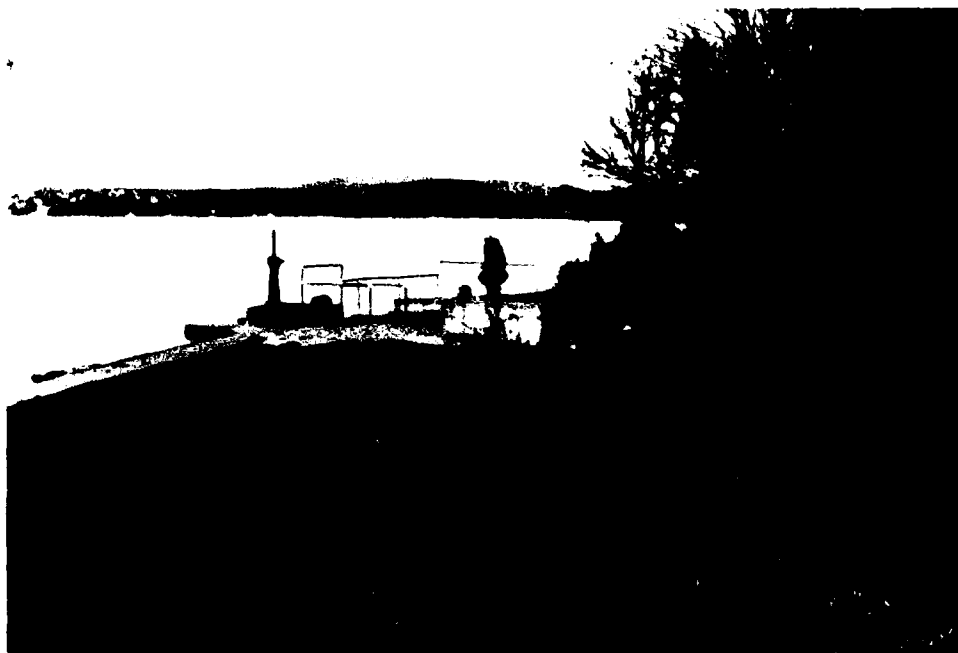
PHOTO NO. 1 - General view of dam and reservoir.

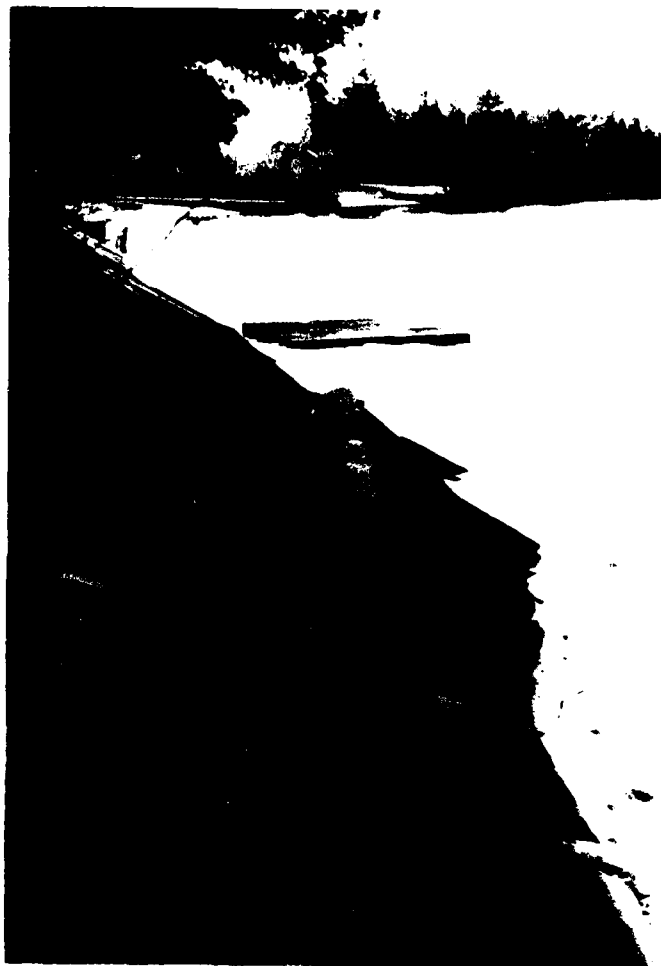
PHOTO NO. 11 - Slope protection  
on left "abutment" beyond con-  
crete core wall.

(b) The broken core wall should be repaired and new slope protection placed as required.
